RETAINING WALL STABILISATION HEREFORD GENERAL HOSPITAL

Client: Hereford General Hospital
Engineers: S. Roughton Associates
Installer: WT Specialist Contracts

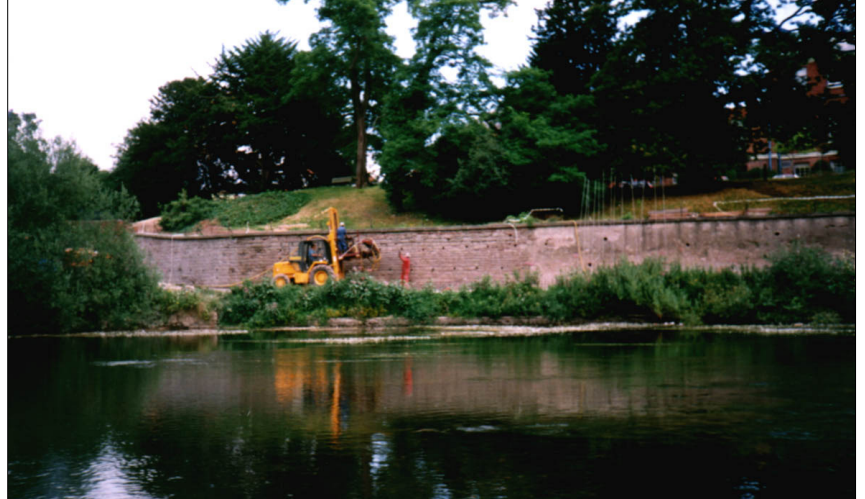
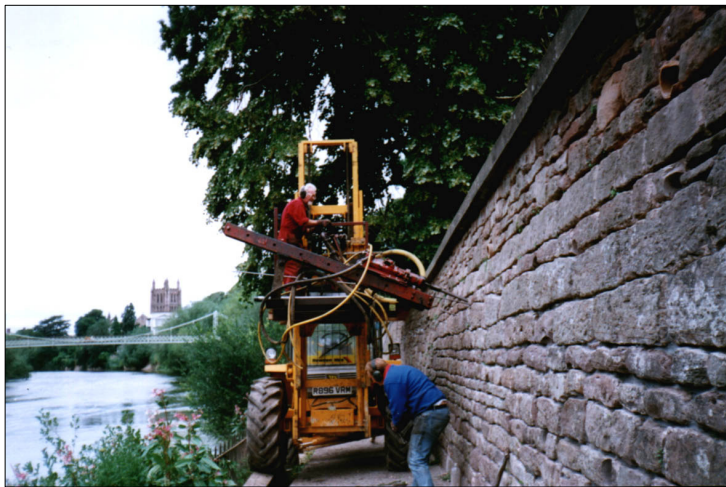
A 3.3m high boundary retaining wall on the grounds of Hereford General Hospital, approximately 90m long, was showing signs of bulging and needed to be reinforced and stabilised. The stone wall stands less than 2m from the bank of the River Wye with a narrow towpath that meant access was difficult and working conditions severely restricted.

Sister company WT Specialist Contracts first reinforced the wall by grouting stainless steel bars into previously channelled-out mortar beds which were then re-pointed.

Following this holes were cored through the wall and the Duckbill MR2 stainless steel anchors with 16mm grip bars were driven, at an angle, 6m into the stiff sands and sandstone.

Using a special rig mounted on an all-terrain fork lift truck WT installed a total of 150 Duckbills in two rows, at heights of 1.1m and 2.2m, before being secured with Combi-Tecs and set to a working load of 25kN.

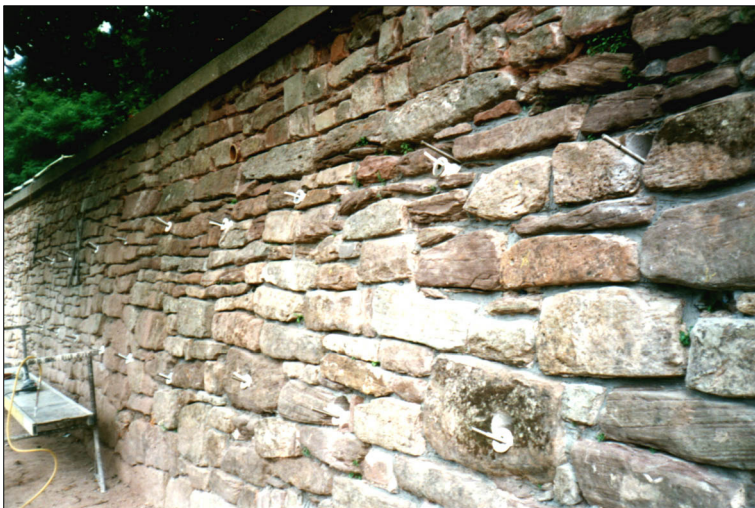
The cored out stonework was then replaced and grouted to hide the anchors and provide an aesthetic finish with virtually no signs of the wall stabilisation work that had been carried out.
